DEPARTMENT OF TRANSPORTATION**DIVISION OF ENGINEERING SERVICES**

Quality Assurance and Source Inspection

Contract #: 04-0120F4Cty: SF/ALA Rte: 80 PM: 13.2/13.9File #: 69.28**WELDING INSPECTION REPORT****Resident Engineer:** Pursell, Gary**Address:** 333 Burma Road**City:** Oakland, CA 94607**Report No:** WIR-001849**Date Inspected:** 29-Mar-2008**Project Name:** SAS Superstructure**OSM Arrival Time:** 630**Prime Contractor:** American Bridge/Fluor Enterprises, a JV**OSM Departure Time:** 2100**Contractor:** Zhenhua Port Machinery Company, Ltd (ZPMC), Changxing Island **Location:** Shanghai, China**CWI Name:** Sun Wei and Chen Chih-ming**CWI Present:** Yes No**Inspected CWI report:** Yes No N/A**Rod Oven in Use:** Yes No N/A**Electrode to specification:** Yes No N/A**Weld Procedures Followed:** Yes No N/A**Qualified Welders:** Yes No N/A**Verified Joint Fit-up:** Yes No N/A**Approved Drawings:** Yes No N/A**Approved WPS:** Yes No N/A**Delayed / Cancelled:** Yes No N/A**Bridge No:** 34-0006**Component:** OBG deck panels**Summary of Items Observed:**

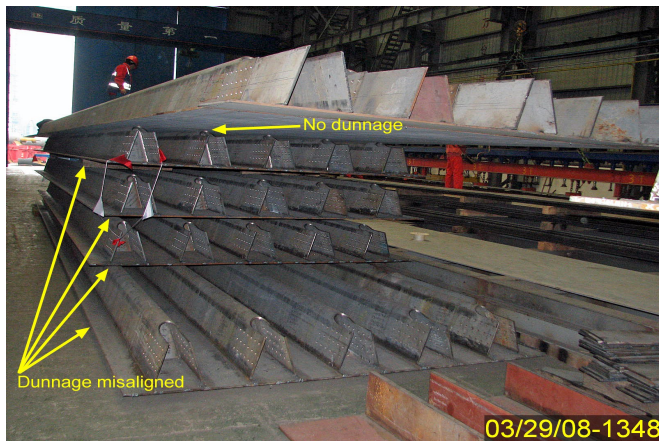
QA noted that ZPMC is stacking the completed deck panels in a manner that appears to be inconsistent with the 1999 standard specifications section 55-1.04. The panels were stacked five high. Given the weight of these panels and the manner in which the dunnage was placed (slightly staggered from one panel to the next) the U-Ribs on the bottom panels are potentially in danger of being damaged due to excessive weight concentrated in the areas where the dunnage has been placed. QA also noted that the top panel did not have any dunnage in place creating a

potential hazard for surface scrapes which is clearly prohibited in sec. 55-1.04 of the 1999 standard specifications. QA brought these issues to the attention of one of ZPMC's QC inspectors. ZPMC personnel were instructed by QC to correct the issue by removing the top panel and lining up the dunnage in such a manner that the lower panels would not be vulnerable to bending.

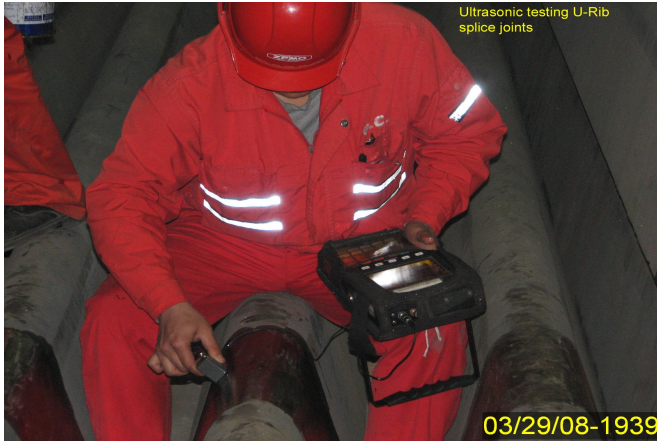
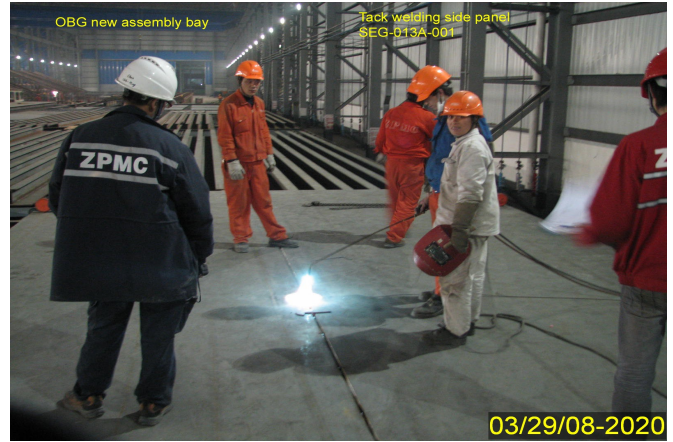
QA observed welding being performed using the Submerged Arc Welding (SAW) process joining BP-005-01-001 to BP-006 to form segment #SEG-014A-003. QA also observed ZPMC personnel tack welding using the Shielded Metal Arc Welding (SMAW) process joining side panels SP-09A to SP-17A to form segment #SEG-013-001. ZPMC QC personnel were observed in both vicinities mentioned above performing WPS parameter verifications and random in process weld inspection.
